SECTION I – INTRODUCTION

Purpose of the Inspection

On March 7, 2016, and March 9, 2016, Jared Richardson from PG Environmental, LLC, a U.S. Environmental Protection Agency (EPA) Contract Inspector, and Colby Tucker from the U.S. EPA Region 9 Enforcement Program (hereafter, we) conducted a Clean Water Act (CWA) National Pollutant Discharge Elimination System (NPDES) inspection of the DCOR, LLC (DCOR or Discharger) – Platform A (hereafter, Facility) offshore oil and gas platform. The purpose of the inspection was to evaluate compliance with the requirements of the EPA Region 9 NPDES Permit Nos. CAG280000 and CAF001156. During the inspection we evaluated the accuracy and reliability of the Discharger's self-monitoring and reporting program and the Facility onsite generated waste streams, treatment processes, and discharges to the Pacific Ocean. The announced inspection consisted of two parts: a records review (conducted onshore on March 7, 2016) and a general Facility walk through (conducted offshore on March 9, 2016). The primary onsite Facility representative was Jay Rao (Environmental Coordinator, DCOR).

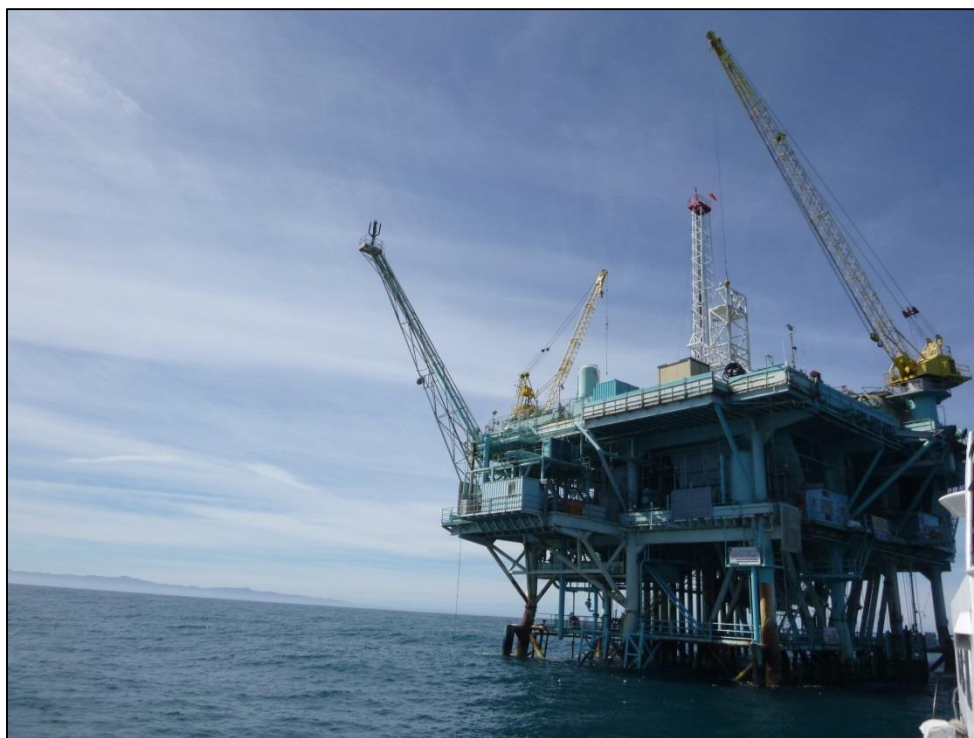
Photograph 1. View of DCOR, LLC's offshore Platform A.

The Platform A is located approximately 5.8 miles offshore in the Santa Barbara channel on the Outer Continental Shelf (OCS) just southeast of Santa Barbara, California (refer to Google Earth Image A below and Photograph 1). The Platform A was installed on September 14, 1968, and began production on March 3, 1969. It is located in the Dos Cuadras Field on federal lease OCS-P-0241 and is situated in 188 feet of water. In 1997 Nuevo took over the operations of the platform from Unocal. In 2004 Nuevo was acquired by Plains Exploration and Production (Plains), who took over operation of the platform. Plains only ran the platform for a little more

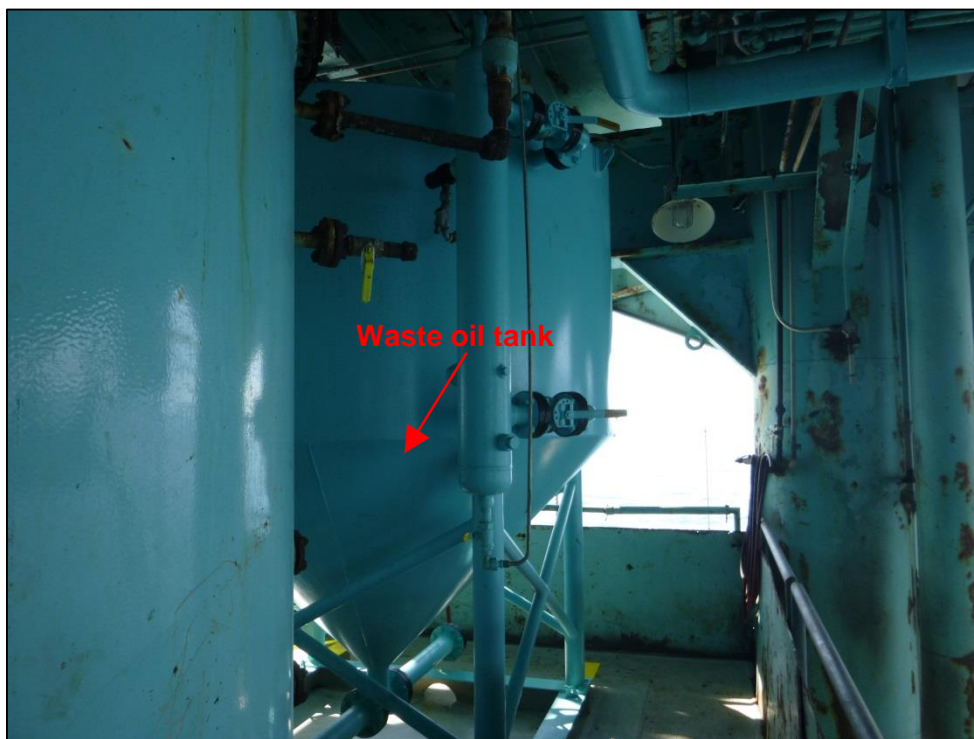
We observed the waste oil tank (refer to Photograph 2), which receives "commingled" deck drainage and fire control system wastewater prior to being pumped via waste oil pumps to DCOR's onshore Rincon treatment facility.

Photograph 2. View of waste oil tank utilized for collecting deck drainage and fire control system water prior to being pumped to DCOR's onshore Rincon treatment facility.

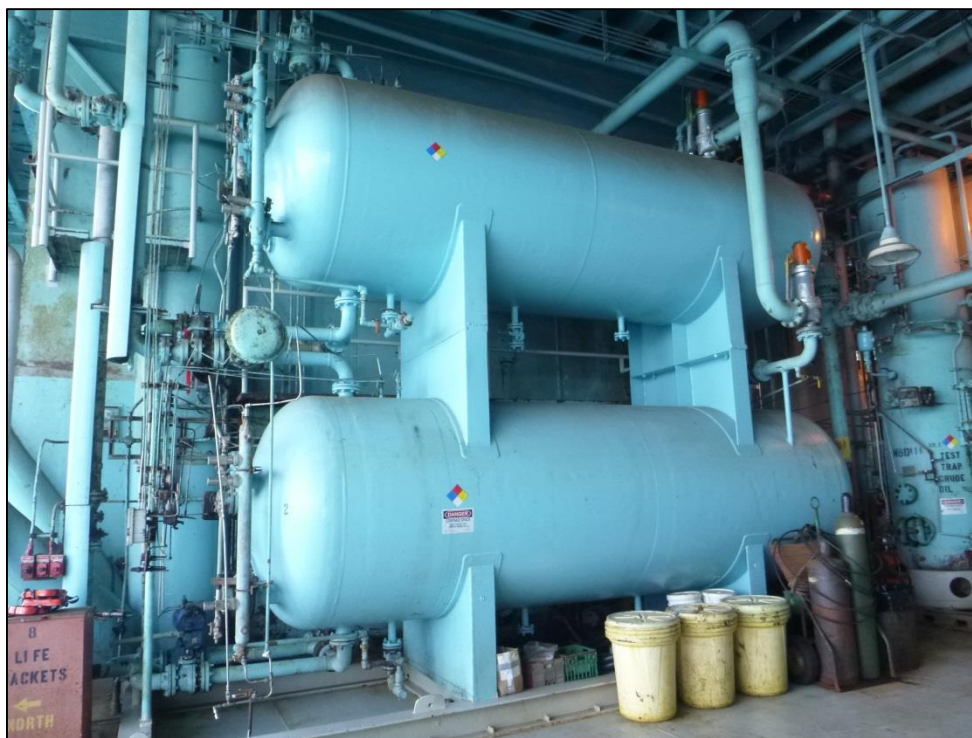
Photograph 3. View of gross oil separators #1 and #2.

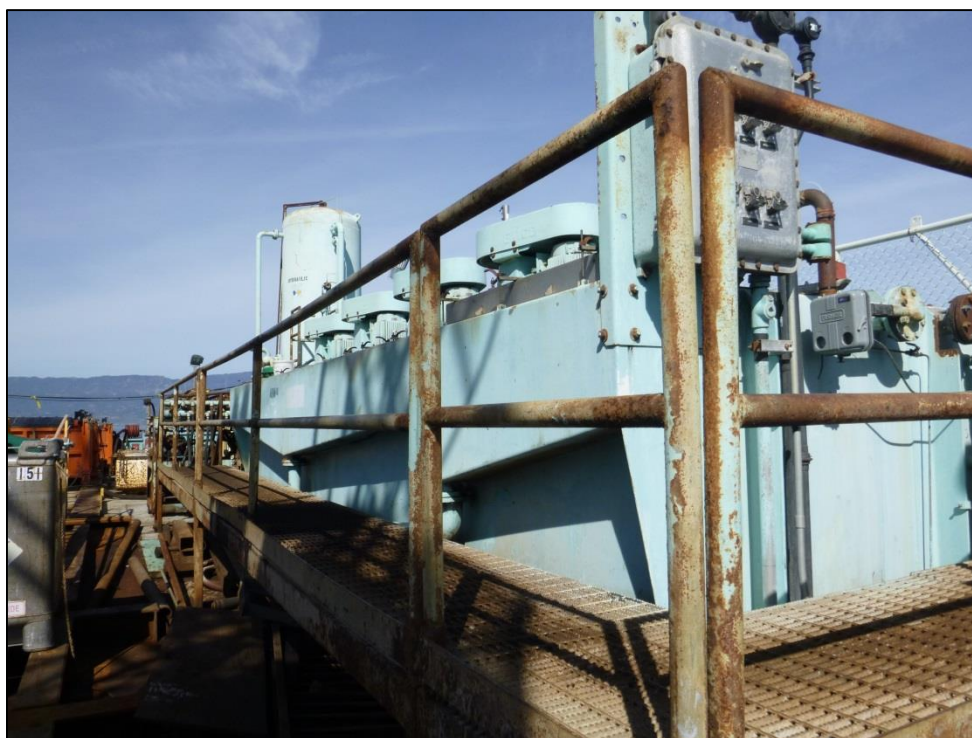
Photograph 4. View of WEMCO oil water separator at the platform.

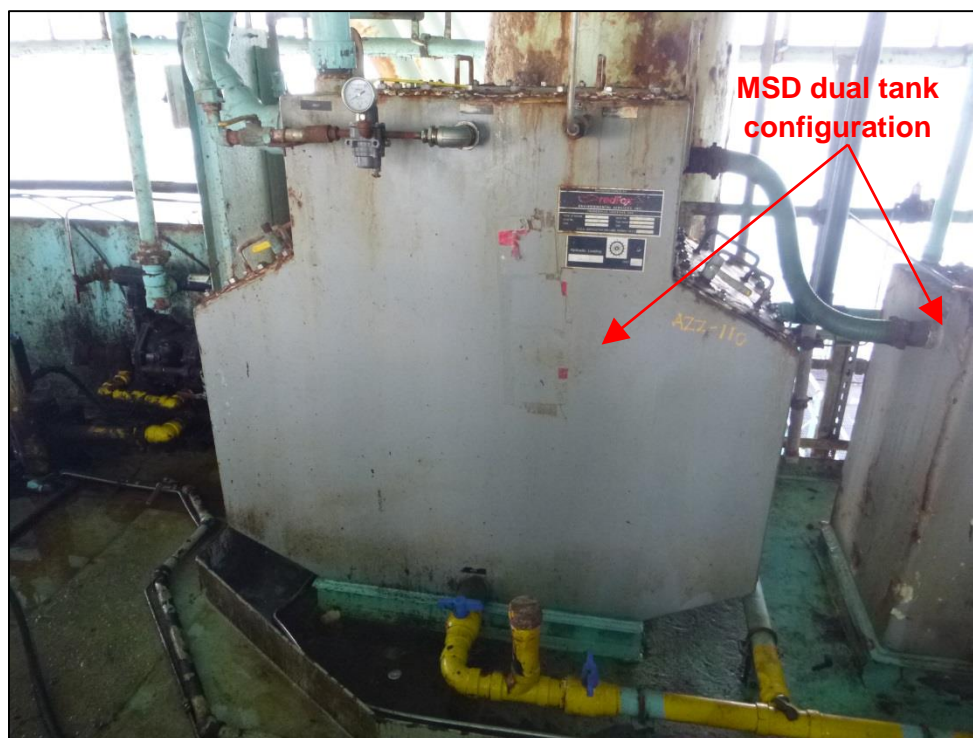
We observed the Facility redFox® MSD used to treat sanitary (black water) wastes (Discharge 005) prior to being discharged to the Pacific Ocean (Discharge 005) (refer to Photographs 5 and 6). The redFox® MSD unit was stamped with a manufacture date of June 29, 2009.

Photograph 5. View of redFox® environmental marine sanitation device Fox Pac Model No. RF-500-FP, Serial No. 4873 used to treat sanitary wastes.

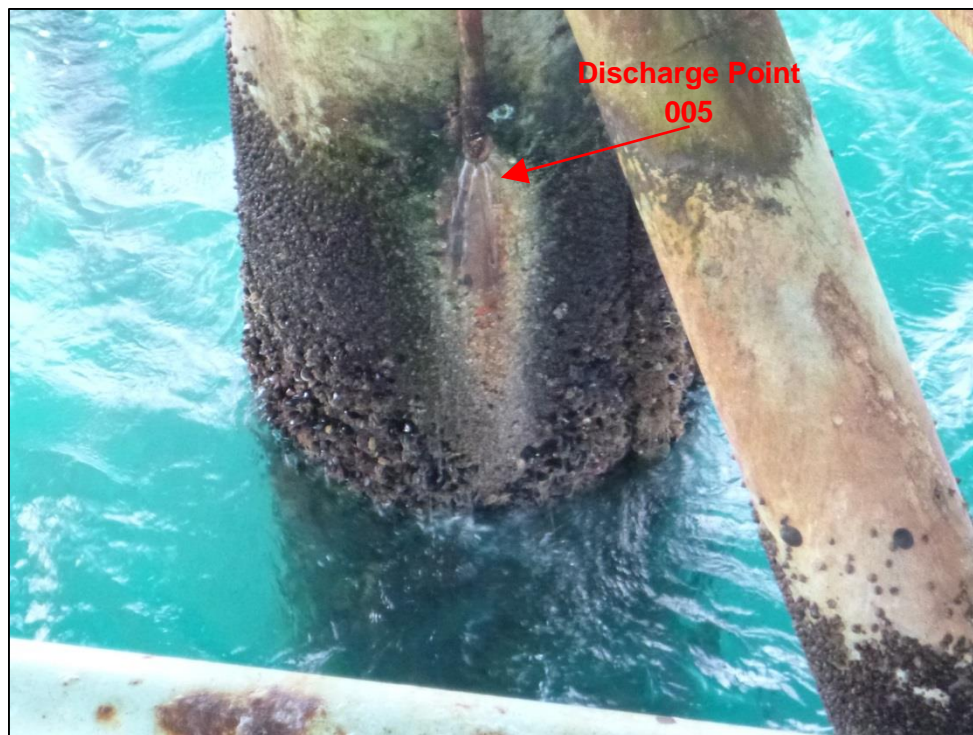
Photograph 6. View of actively flowing sanitary waste discharge point (Discharge 005) to the Pacific Ocean.

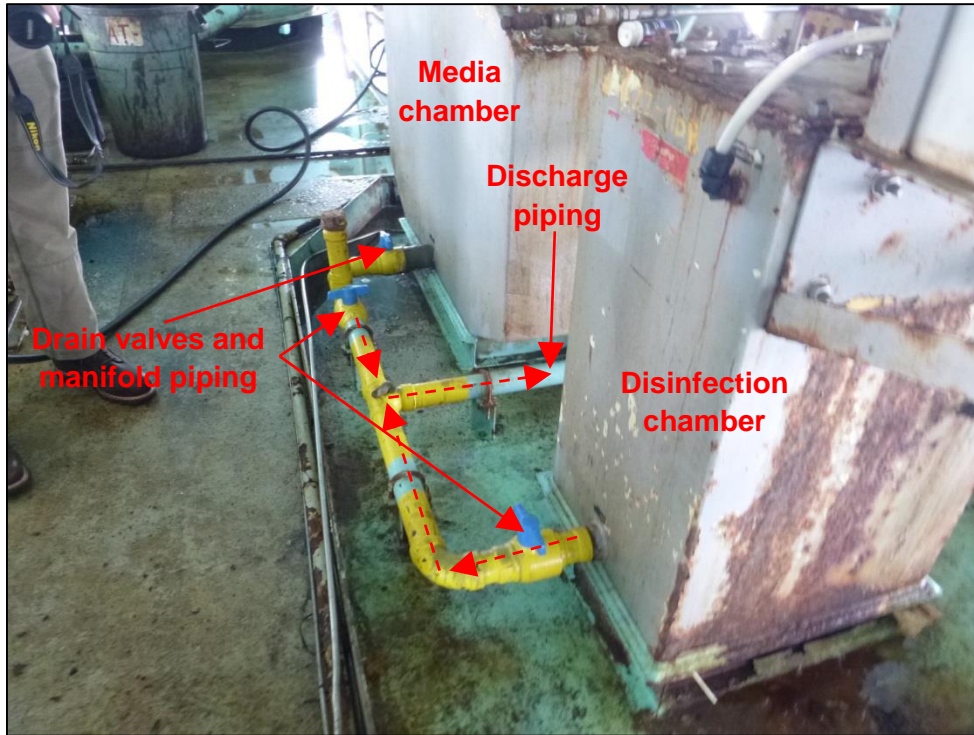
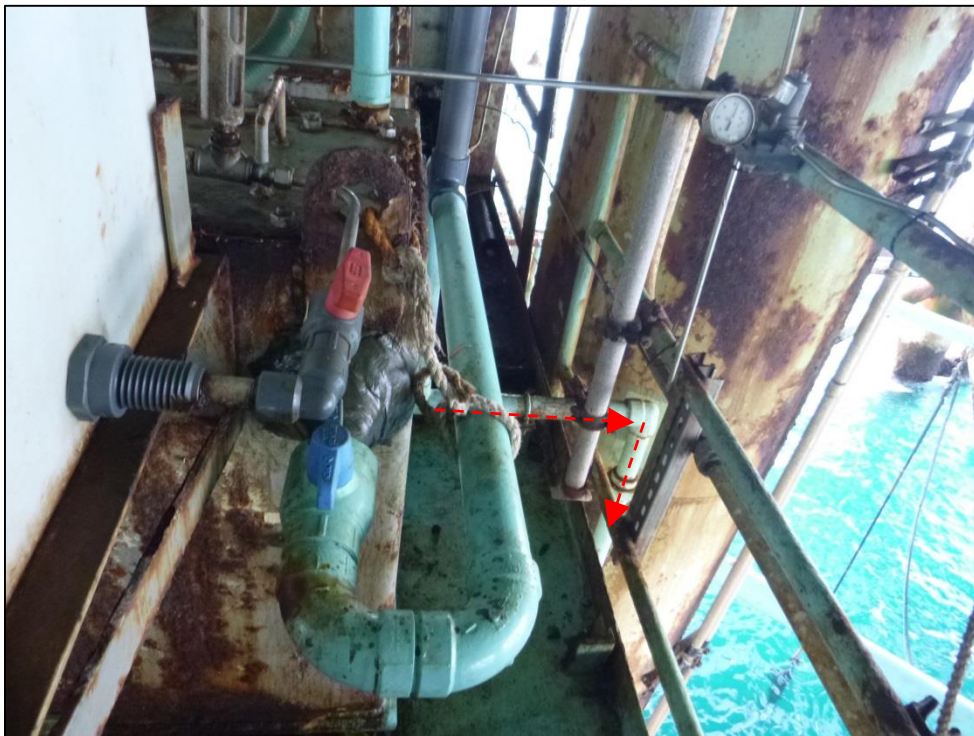
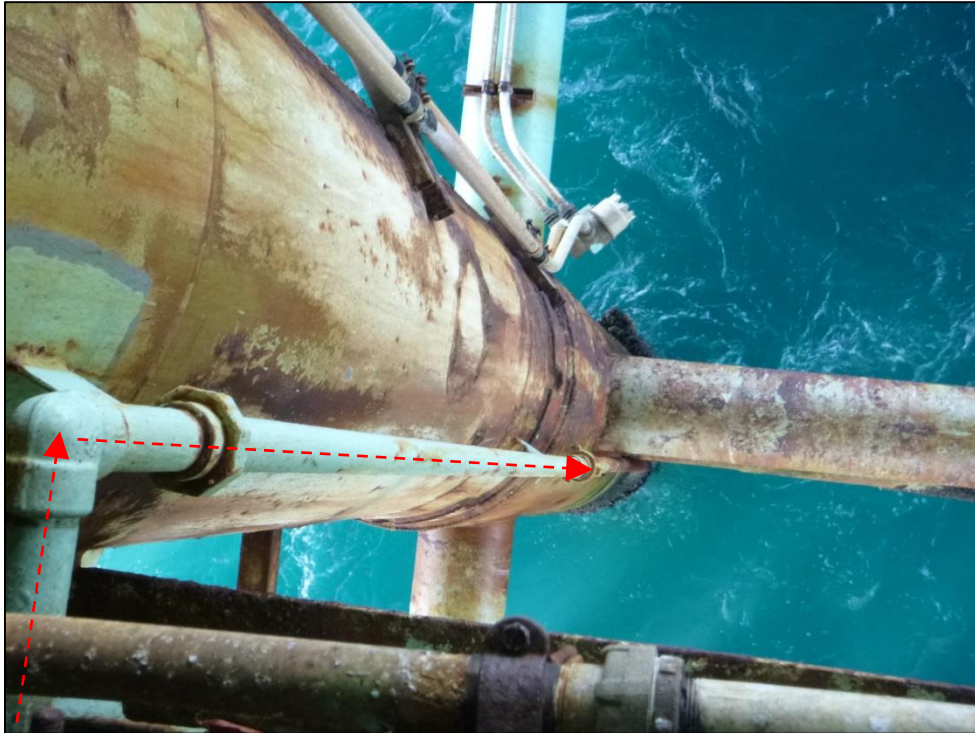
We observed that the Facility MSD unit was equipped with drain manifold and valves between the media chamber and disinfection chamber with the drain piping discharging directly to the Pacific Ocean (refer to Photographs 7, 8, and 9). At the time of the inspection all chamber drain valves were closed and no discharge was observed from the discharge piping to the Pacific Ocean. Facility representatives did not know at the time of the inspection, if any discharges ever occurred from the MSD unit media and disinfection chambers via this discharge piping.

Photograph 7. View of MSD unit media chamber and disinfection chamber drain valves and manifold. Note that the drain valves were in the closed position at the time of the inspection.

Photograph 8. View of discharge piping from the MSD unit media and disinfection chambers, shown in Photograph 7.

Photograph 9. View of discharge piping outfall to the Pacific Ocean from the MSD unit media and disinfection chambers drain manifold piping.

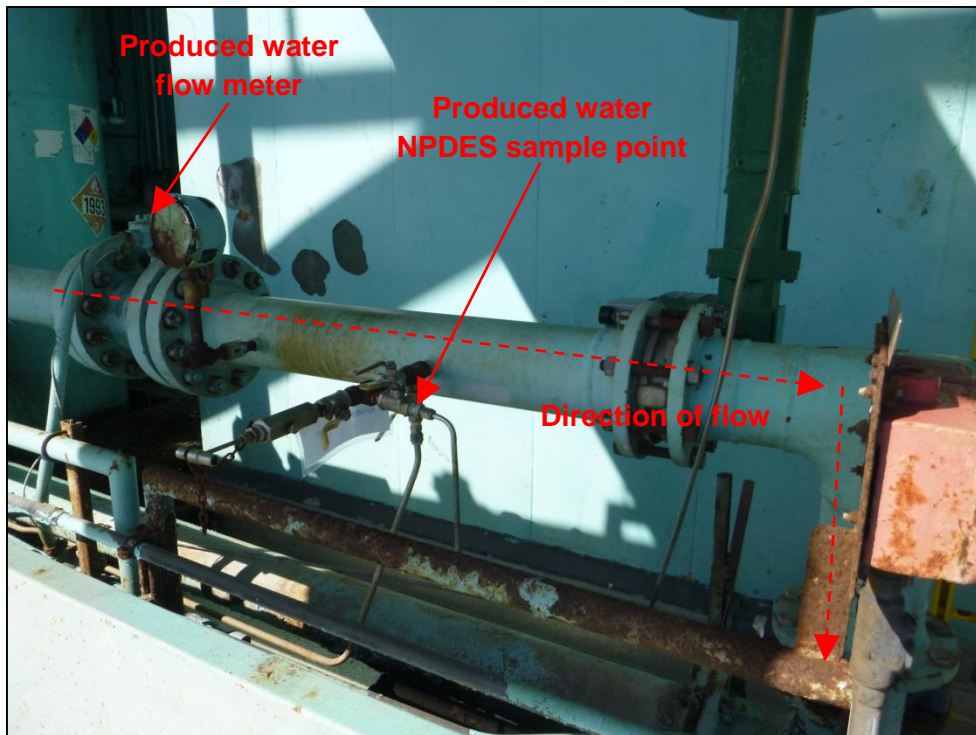
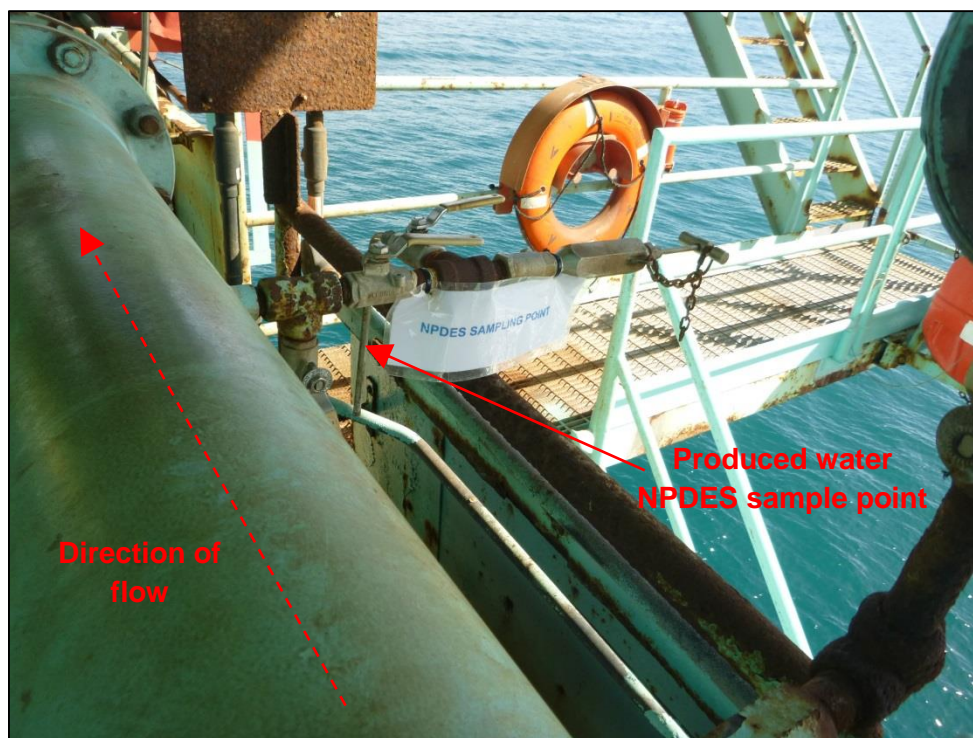
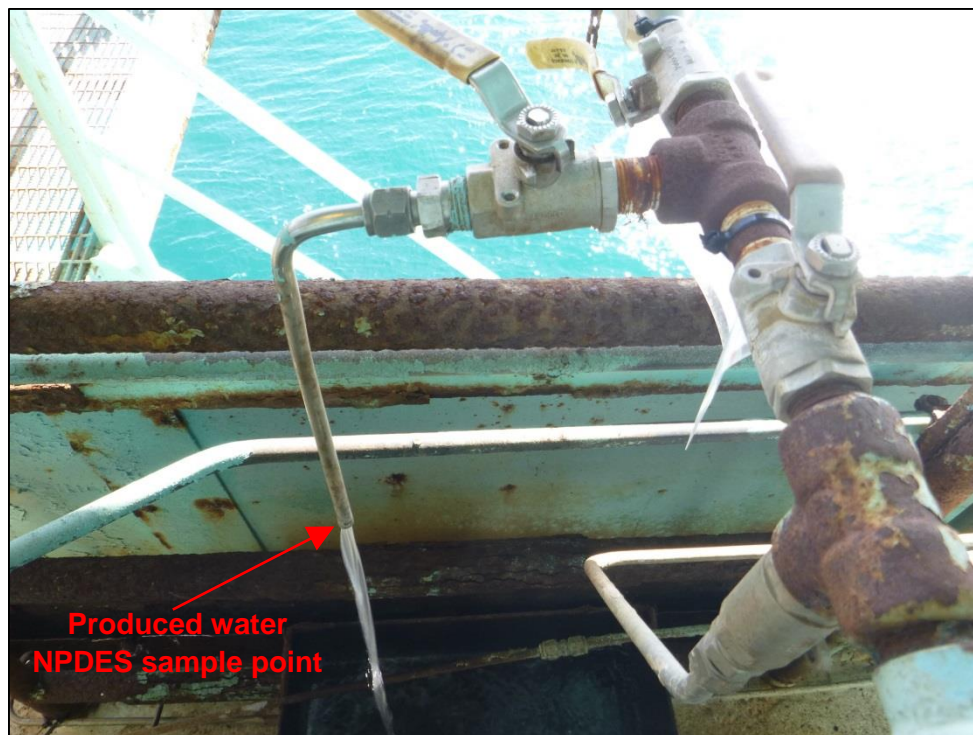
During the Facility walk through, we observed the Facility produced water treatment train. The Discharger's produced water (Discharge 002) NPDES sampling point is located at the discharge pipe off of the WEMCO. We viewed this discharge pipe as a component of the inspection (refer to Photographs 10, 11, and 12). Based on our observations during the inspection, the produced water NPDES oil and grease sample location appeared to provide representative samples; however, we observed a bypass line around the NPDES sample point during the inspection (refer to Photographs 13 and 14). We observed that the produced water NPDES sample point bypass piping was not in operation during the inspection, as indicated by the closed valve (refer to Photograph 14). The receiving water (Pacific Ocean) within the vicinity of the produced water discharge pipe was viewed and observed to be free of visually objectionable characteristics at the time of the inspection (refer to Photograph 15).

Photograph 10. View of produced water (Discharge 002) NPDES sampling point located off of the discharge pipe from the WEMCO with the produced water flow meter.

Photograph 11. Alternate view of produced water (Discharge 002) NPDES sampling point located off of the discharge pipe from the WEMCO.

Photograph 12. Close-up view of the produced water NPDES sampling point, shown in Photographs 10 and 11.

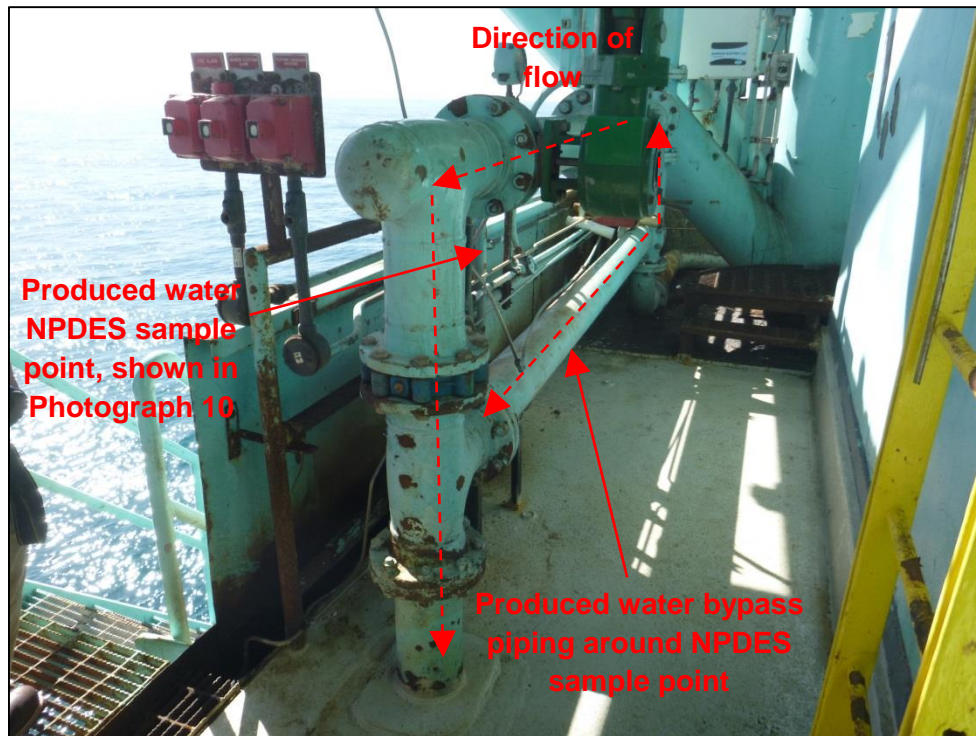
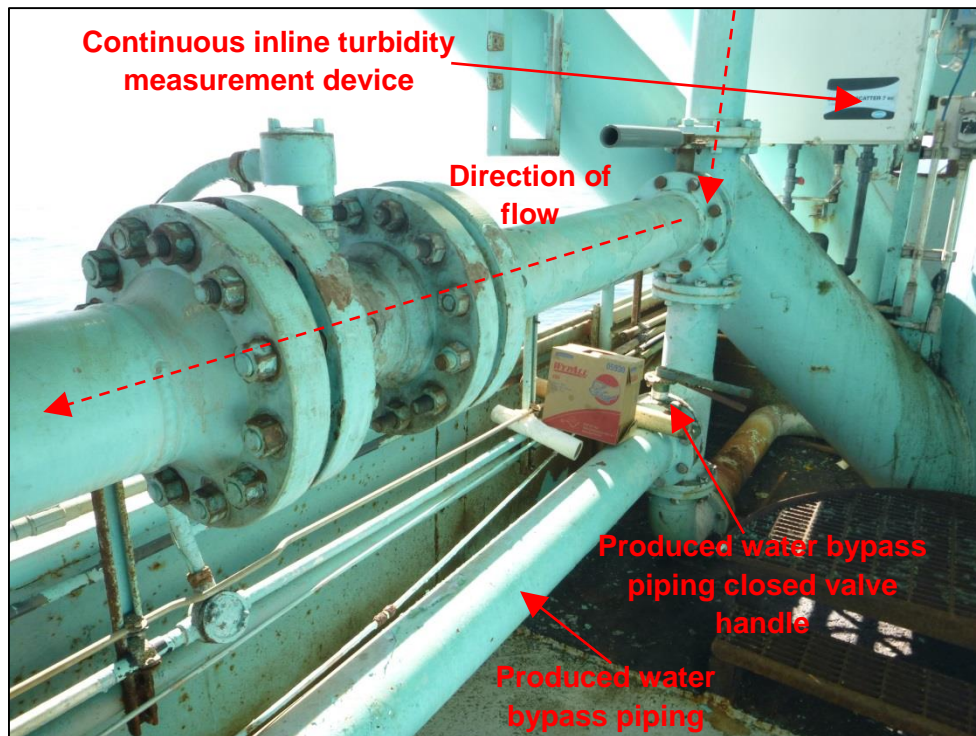
During the inspection, we observed a bypass line around the produced water NPDES oil and grease sample location (refer to Photographs 13 and 14). At the time of the inspection, the produced water NPDES sample point bypass piping was not in operation as indicated by the closed valve (refer to Photograph 14). Facility representatives were unaware of the frequency or reason for the bypass of the produced water oil and grease NPDES sample point.

Photograph 13. View of produced water bypass piping around NPDES sample point.

Photograph 14. Close-up view of produced water bypass piping around NPDES sample point, shown in Photographs 11. Note the bypass piping was not in operation at the time of the inspection, as indicated by the closed valve handle.

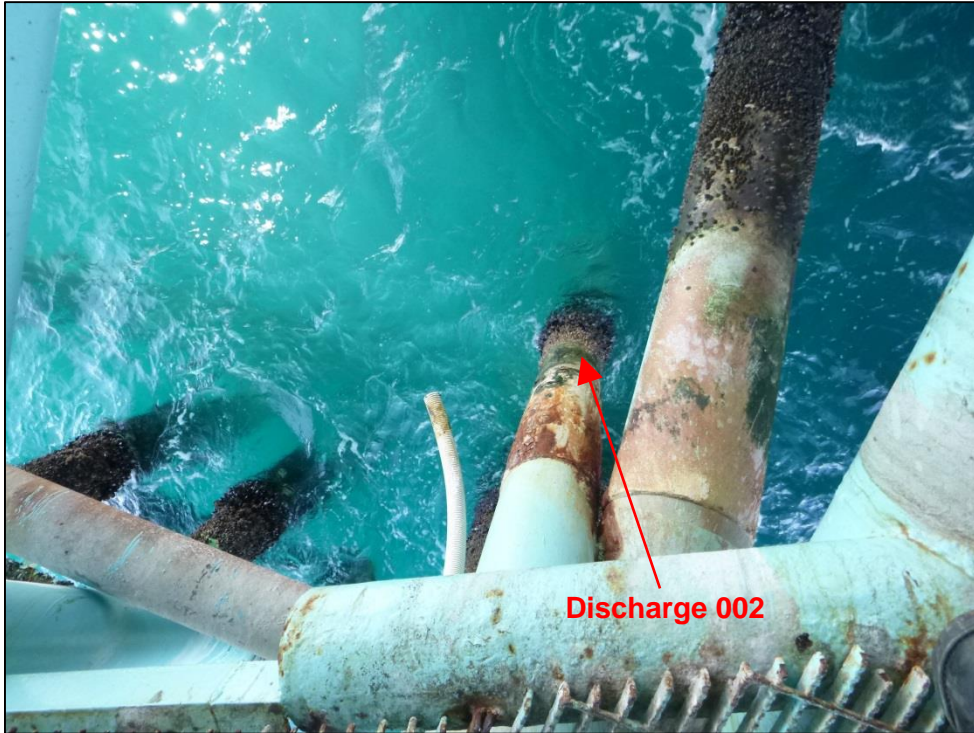
Photograph 15. View of the receiving water (Pacific Ocean) within the vicinity of Platform A NPDES produced water submerged outfall discharge pipe at the time of the inspection.

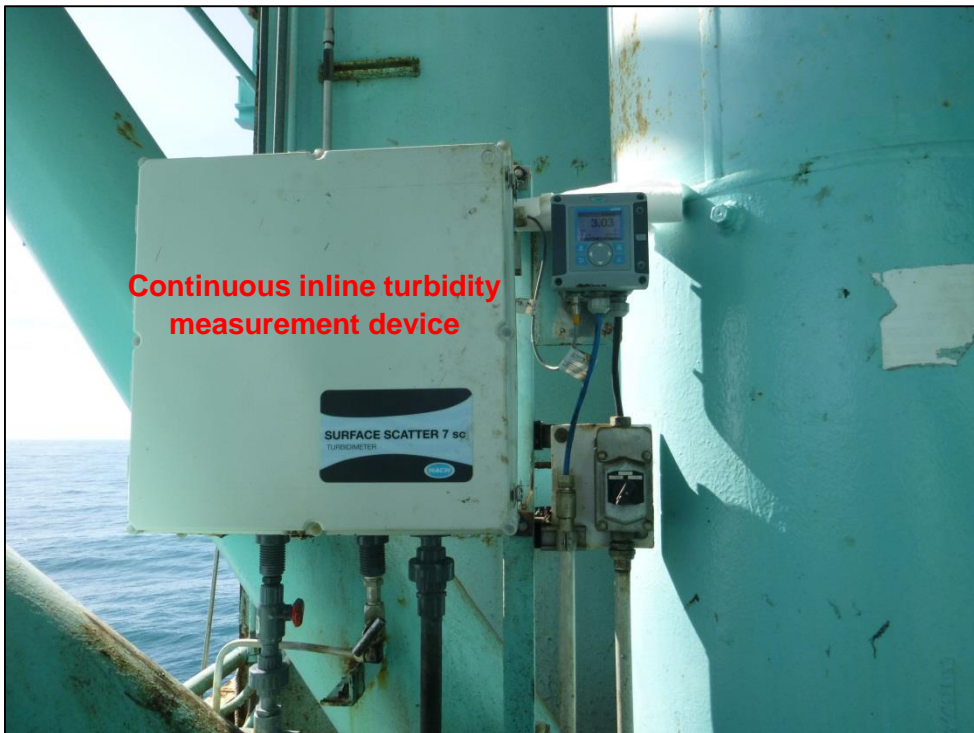
We observed the Facility's on-line oil and grease monitor, which was installed in accordance with Part II.G.6, On-Line Oil and Grease Monitors, requirements of the Permit. The Discharger conducts additional internal process monitoring for oil and grease in produced water after the WEMCO on the discharge pipe via continuous inline turbidity measurement utilizing a HACH Surface Scatter® 7 sc turbidimeter (refer to Photographs 14 and 16). At the time of the inspection, we observed the continuous inline turbidity measurement of produced water to be 2.58 nephelometric turbidity units (NTUs). The Facility representatives stated that there is an alarm (visual and audible) that activates when the inline turbidity monitor exceeds 15 NTU and 20 NTU. The Facility representatives stated that these set points were to ensure the produced water (Discharge 002) did not exceed the monthly average and daily maximum oil and grease Permit effluent limits of 29 mg/L and 42 mg/L, respectively. The Facility representatives said the set points were developed based on facility-specific correlation between the turbidity monitor and oil and grease measurements.

Photograph 16. Close-up view of continuous inline turbidity measurement device (shown in Photograph 14), a HACH Surface Scatter® 7 sc turbidimeter, used to comply with Part II.G.6 On-Line Oil and Grease Monitors of the Permit.

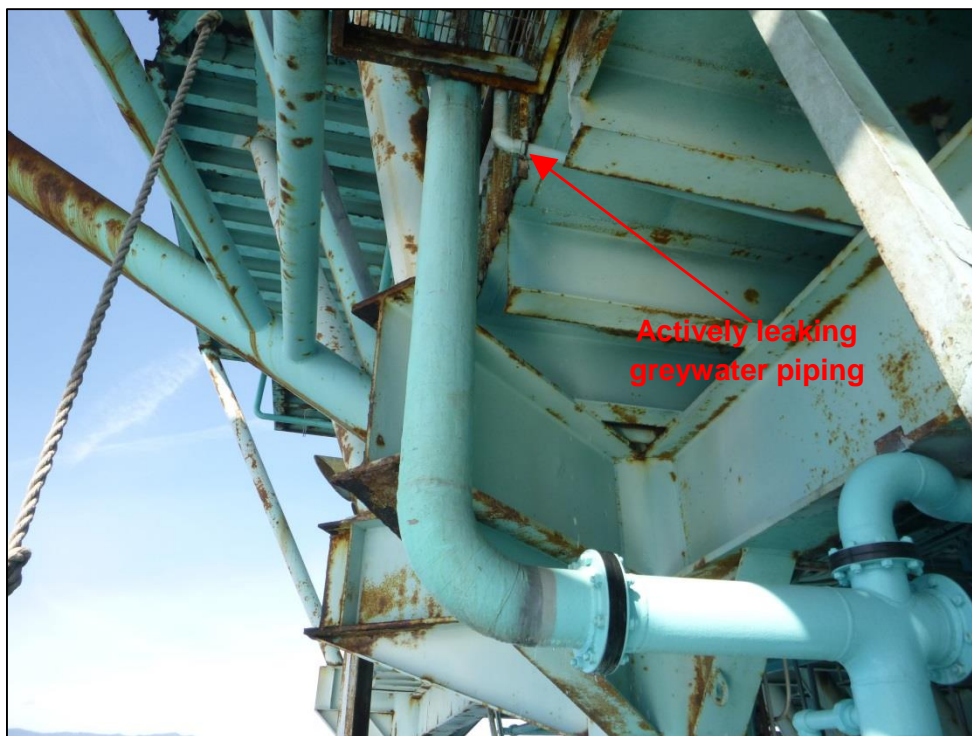
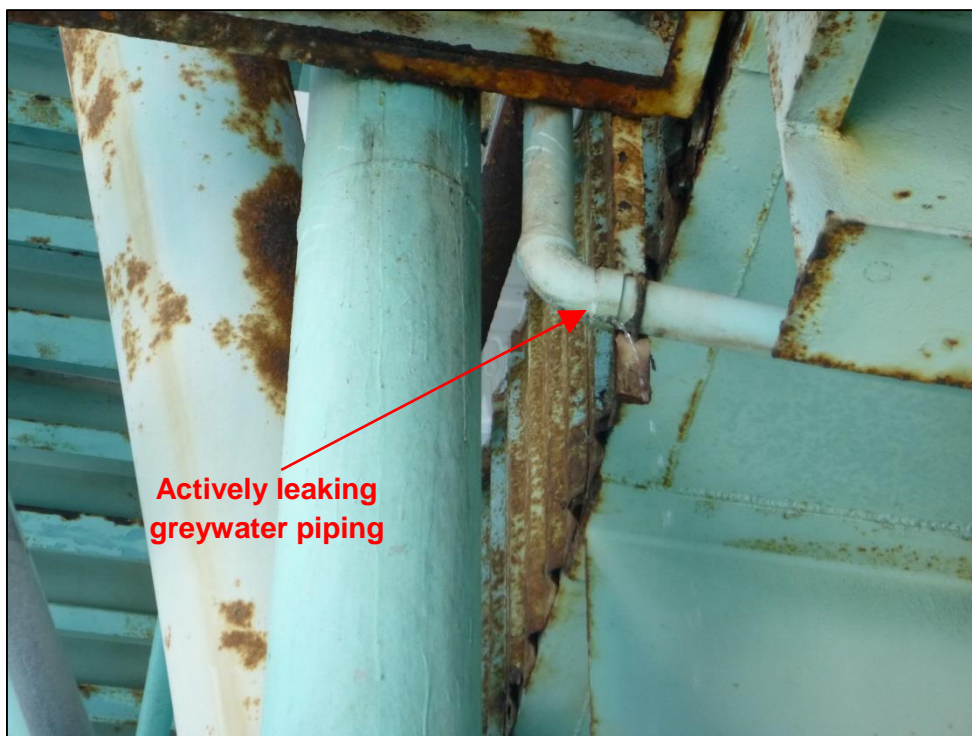
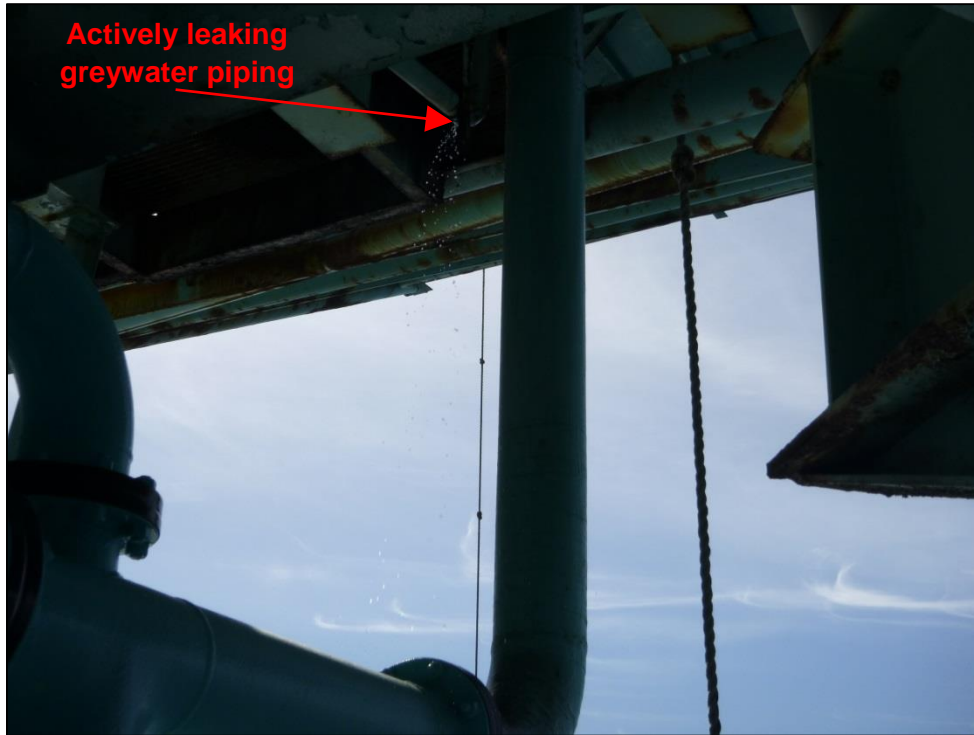
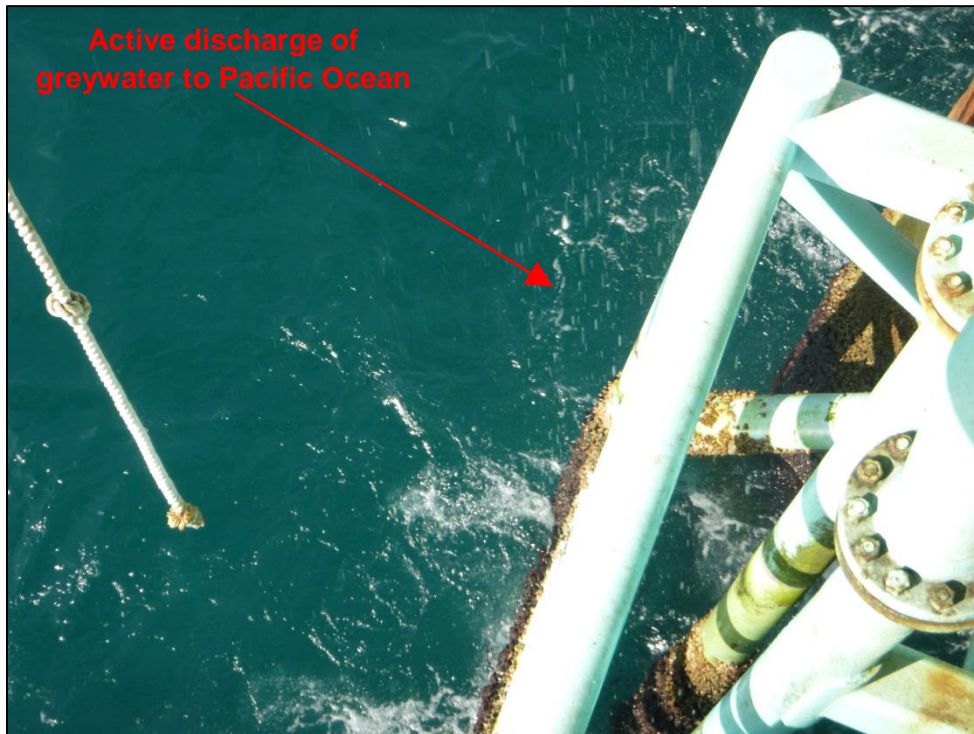
We observed an actively leaking domestic (greywater) piping discharging to the receiving water (Pacific Ocean) at the time of the inspection (refer to Photographs 17 through 20). Facility

representatives stated that the greywater piping leak appeared to be originating from the galley drain system.

We observed an active domestic (greywater) piping leak discharging to the receiving water (Pacific Ocean) at the time of the inspection (refer to Photographs 17 through 20). As a result of the leak, not all greywater was being discharge at the designated discharge location (Discharge 005). Facility representatives stated that the greywater piping leak appeared to be originating from the galley drain system. During the inspection, Mr. Rao stated that they would promptly address the greywater leak and notify EPA Region 9 once completed.

Photograph 17. View of the location of the active domestic (greywater) piping leak.

Photograph 18. Close-up view of active domestic (greywater) piping leak.

Photograph 19. Alternate view of active domestic (greywater) piping leak.

Photograph 20. View of receiving water (Pacific Ocean) in the vicinity of the active domestic (greywater) piping leak discharge. Note the droplets showering down in the photo from the greywater leak shown in Photographs 17, 18, and 19.
